DOT/FAA/AR-96/10

The Role of Fretting Fatigue on Aircraft Rivet Hole Cracking

October 1996

Final Report

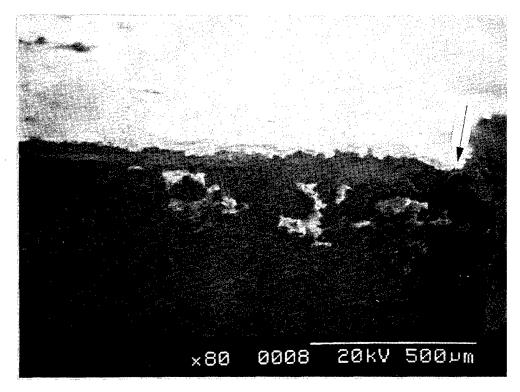
Figure 29. Fracture surface (bottom of picture) for crack from a fretted area (see arrow) between the plates. The substance at the top of the picture is interfay sealant.
